## **Preliminary Report**

Sioux Silo Failure Investigation Tepic, Mexico.

ESI Project: 47623T AIG Claim: NX0008863

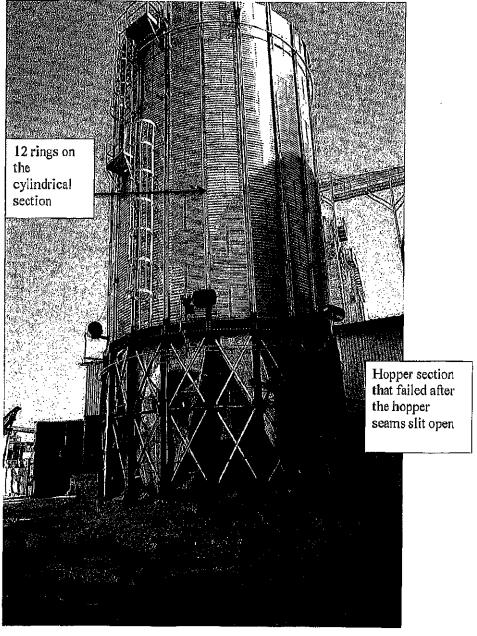
The incident silo was a 30 feet diameter galvanized steel hopper type silo (with 12 rings on the Cylindrical section) supported on 20 steel columns. The hopper was conical with 45° slope with a central discharge (see Fig. 1). The failure occurred when the conical hopper laminates split open causing the sudden spill of the soybean meal underneath the silo, thereby burying two 'Agropecuaria El Avion' workmen who were operating the silo at that time; and resulting in the demise of both workers as a consequence of this failure.

Flg. 1: View of the 30' diameter Sioux failed silo.

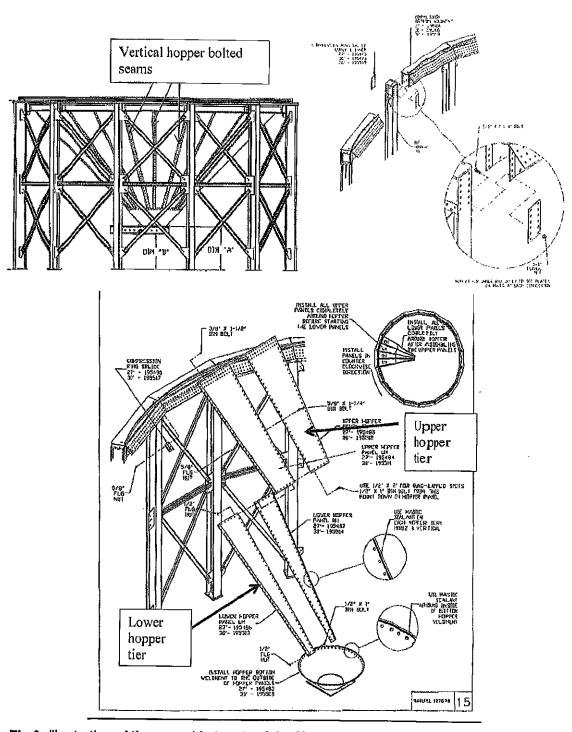
Fig. 2: Illustration of the assembled parts of the Sioux hopper siles. Sioux Manual No. 197870.

It is important for the purpose of the analysis developed in this report to provide details of the assembly of the hopper section of this grain bin; the part that failed. As can be seen from the illustration of Fig. 2, the 30' conical hopper is assembled by using two tiers of trapezoidal shaped panels or laminates (denominated upper hopper and lower hopper) which are bolted together around the edges to adjacent ones to form the cone (bearing type connection). The bottom section of the lower tier of laminates is bolted/connected to the top perimeter of the bottom central discharge cone.

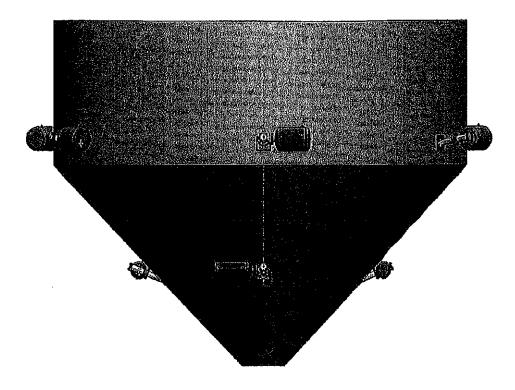
Fig. 4: Air cannons location on the referenced sllo.

The referenced hopper-silo was furnished with ten (10) air cannons, six (6) on the bottom of the cylindrical part of the silo (top ones) and four (5) on the hopper section (bottom ones) to help and procure the flow of the stored material out from the bottom of the silo (see Fig. 4). The working mechanism of these cannons is configured in such a way that they operate spurting/discharging dry air (stored pressurized at 140 psi per container) into the interior of the silo, and they are triggered consecutively counter-clockwise every 20 seconds, first the top ones and then the bottom ones, with the purpose of producing a motion of the soybean meal (in this case) which is driven by the air flows at the bottom section of the silo in order to propel/procure the material discharge through the opening of the central bottom cone of the hopper. At this plant, the discharged soybean meal was intended to feed another conveyor, installed at the base of this silo, in order for it to be transported to another part of the plant for further processing.

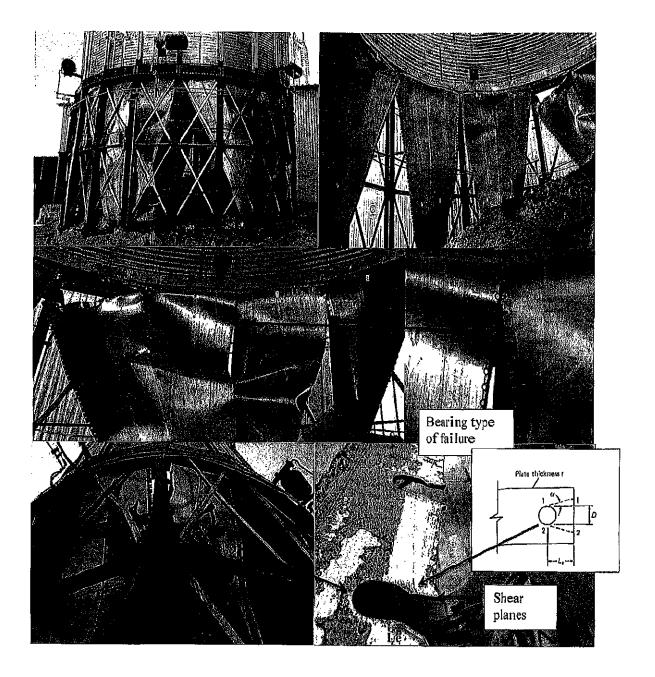
After examining the failed hopper, it could be corroborated that the hopper shell split open at the seams (see Fig. 5). As can be observed from the pictures of Fig. 5, it is evident that some fasteners used to attach together the hopper laminates tore through the ends of the laminates' edges causing a bearing type of failure of the bolted joint due to shear stresses (on the laminate edges). Therefore, it is clear that hoop stresses (or circumferential stresses) acting perpendicular to the seams, pulled those seams apart and then caused the failure of some bolted joints at those seams of the hopper. Following are the circumstances that led to that failure.

Fig. 5: Photo of the hopper failure.

• It could be corroborated that the root cause of the failure of the hopper section of the referenced silo was that the hopper shell split open at the seams. It is evident that some fasteners that were used to attach the hopper laminates together, tore through the ends of the laminates' edges causing a bearing type of failure of the bolted joint due to shear stresses (on the laminate edges).

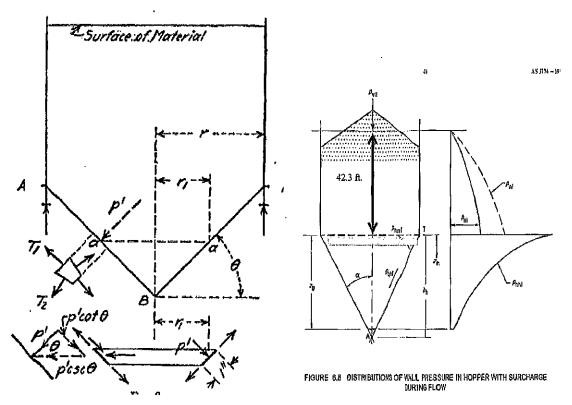
Fig. 6: Pressures on the hopper shell during flow.

The pressures and also in effect the stresses on the hopper wall or shell are different from when the stored material is in stationary mode or condition to the condition; to those of when that material is being discharged or funneled. Fig. 6 shows the normal pressure on the bin walls abruptly increases during the transition from the cylindrical part of the bin to the conical part of the bin; during flow of the material (or funneling condition).

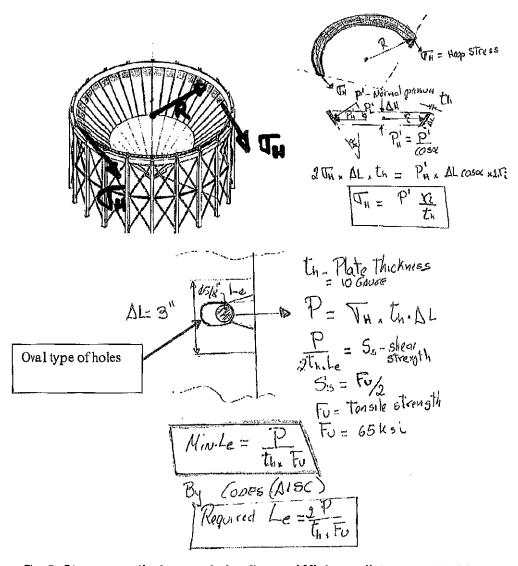
Fig. 7: Stresses on the hopper during flow and Minimum distance required for the bolted connection.

The hoop stresses  $(\sigma_b)$  are proportional to the normal pressure (p') and the radius 'r<sub>i</sub>' and inversely proportional to the thickness of the shell on the circumferential/circular cross section of the cone.

Table 1 and Table 2 also show the calculation of the generated hoop stresses at three critical points on the cone, starting at the edge or transition point cylinder-cone point at 42.2 ft. down to 44.5ft. Although the normal pressure on the hopper shell increased at the lower circular strips of the cone, the hoop stress would decrease as the radius of the radius of the circular sections (cone) become smaller (see Fig. 7).

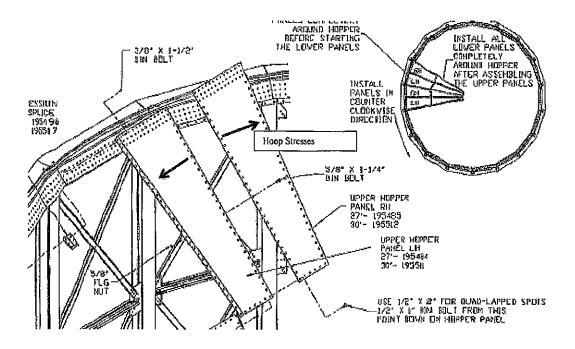
Fig. 8: Hoop/Circumferential Stresses.

The hoop stress at each circular section of the conical hopper would be transmitted from the laminate to adjacent laminate through/by the bolted connection between those panels (see Fig. 8) and as it was stated earlier in this report those hoop acting perpendiculars to the seams, would pull the seams apart.

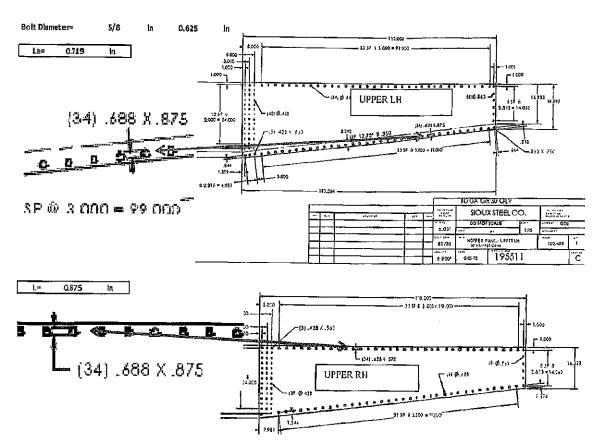
According to the '30' HOPPER CONE' hopper assembly of this silo, there are two types of laminate or panel configurations which make up the upper tier of the hopper cone, the 'Upper RH' and 'Upper LH' type laminates. The details of those two panels are illustrated in Fig. 9. Along the four edges of these panels there are the bolt bores (on the seams sides at 3 inches apart from each other, ΔL) for the bolt connections with their adjacent panels. Both types of panels have along one side, that would make up the vertical seams, oval types of holes or slots for the bolted connection (see Fig. 7), and the distance 'Le' from the hole edge to the laminate edge is different for each type. As shown in the formulas of Fig. 7, that distance 'Le' plays a huge role in the strength of the bolted connection towards not inducing a bearing type of failure on the panels' edges due to the forces/stresses conveyed through the bolted joint at the seams. Based on the panel drawings, in theory the 'Upper LH' panel type had a distance 'Le' of 0.875 inches approximately (see Fig. 10).

Fig. 9: Details of hopper 'Upper RH' and 'Upper LH' type laminates and their bolt holes configuration.

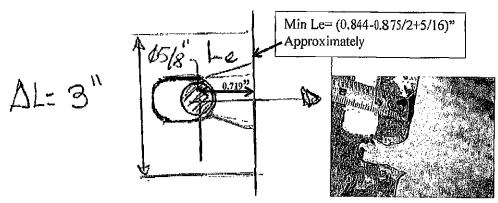
Fig. 10: Details of Panel LH 'Le' calculation.

Table 1 and Table 2 also show what would be the actual distance 'Le' in order to not have a bearing failure at the bolted joints at the three points of the cone considered. Actually, a minimum 'Le' value of 0.53" on the bolted connections at about 1 ft. from the top of the hopper cone (43.5) would be required for the initial conditions when the silo was started to be emptied, to avoid a failure; that distance was very close to that which was actually existing at the seam bolted joints of 0.719". However, the failure did not occur until after about 10 to 15 minutes of the beginning of the empting of the material; at which time, the pressure of the material had decreased. Table 3 shows calculations of the stresses and minimum required 'Le' values for not having shear failure on the laminates' edges on the bolted connections for different elevations after the empting process had started and Volumes of 90% and 80% had been reached.

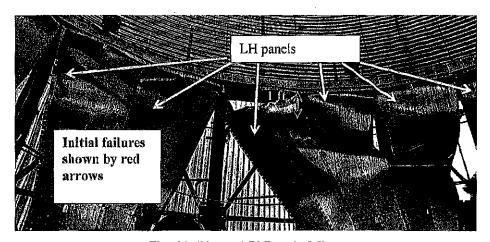
The majority of the panels, where their edges failed, were the 'LH' type and the failures started at about 1 ft. below the top of the hopper cone (see Fig. 11). After one of the bolted joints failed at each seam then the adjacent joints were not able to resist the extra stresses conveyed to them and a chain reaction type of failure occurred all the way down the seams from the initially failed joint.

Flg. 11: 'Upper LP' Panels failure.

- The vertical seams of the hopper failed due to 'bearing' type of failure on the panels' edges due to the
  forces/stresses conveyed through the bolted joint at the seams by the created hoop stresses. The required
  distance 'Le' of the vertical connections (vertical seams) for avoiding a bearing type of failure was
  insufficient, which thereby propelled the failure of the hopper.

- The majority of the panels, where edges failed, were the 'LH' type and the failures started at about 1 ft. below the top of the hopper cone (see Fig. 11). After one of the bolted joints failed at each seam the adjacent joints were not able to resist the extra stresses conveyed to them and a chain reaction type of failure occurred all the way down the seams from the initially failed joint.

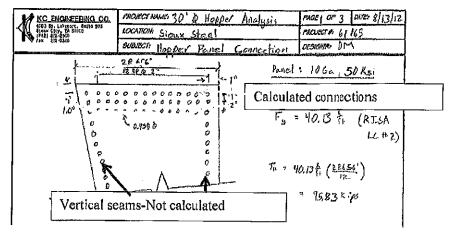
ESI was provided with the engineering and structural analysis for the referenced Sioux-30' diameter hopper type silo performed by 'KC Engineering' (hereinafter KC) located in Sioux City, Iowa. From the document provided to ESI we could verify that this engineering analysis did not consider or include any calculation for the bolted connections of the vertical seams of the hopper. The only connections that were calculated by KC were the top connections of the hopper with the ring of the bottom of the cylinder of the silo (see Fig. 14).

Fig. 14: Hopper panel connection calculations from KC.

The lack of the consideration for or the overlooking of the hoop stresses effect on the bolted connections of the silo hopper seams in the structural analysis performed by KC can be considered as a serious engineering oversight; an oversight that actually was the principal cause of the failure of this hopper silo. In an engineering analysis of this importance and level in which individuals' lives can be in jeopardy, it is mandatory to check all the structural members of the structure, such as the bolted connections
